Manhole Inspection Summary

Manhole # S37EE1094MH

Record Plat: **37EE1** Node: **094** Status: **New Manhole (Not in GIS)** Insp Date: **4/18/07 12:00 AM**

Location Address: **3800 JUNIPER RD** Cross Street: **CHANCERY RD**

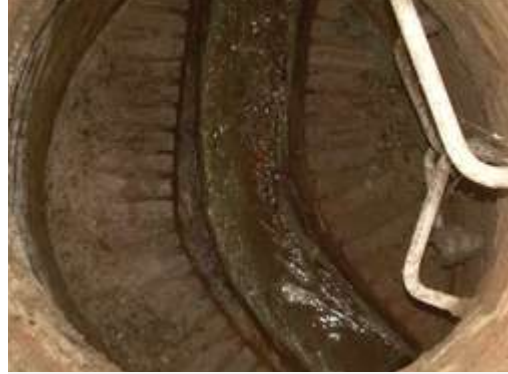
Top View

Bench ☒ Exists Material: **Brick** ☐ Parged ☒ **Debris** (not Condition related)
Condition: ☒ Sound ☐ Cracked ☐ Root Intrusion ☐ Deteriorated ☐ Leaks ☐ Debris

Surcharge ☒ **Evidence Of Surcharge** Depth: **1.5** (ft.) ☐ Active Surcharge Present

Evidence of surcharge - Bench debris.

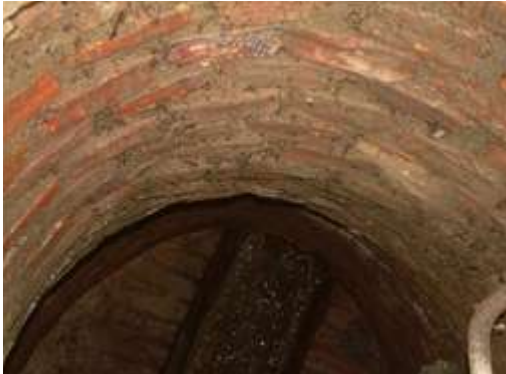
Defect

Frame Offset: **0** (in.) Condition: ☐ Sound ☐ Cracked ☒ **Leaks**

Chimney / Frame Adjustment ☒ Exists Material: **Brick** ☐ Parged Height: **36** (in.)
Condition: ☐ Sound ☐ Cracked ☐ Root Intrusion ☐ Loose Brick ☒ **Deteriorated**
Infiltration: ☐ None ☒ **Joint** ☐ Cracks ☐ Mortar ☐ Roots ☒ **Wall**

Corbel Material: **Brick** ☐ Parged Type: **Concentric/Eccentric**
Condition: ☒ Sound ☐ Cracked ☐ Root Intrusion ☐ Loose Brick ☐ Deteriorated
Infiltration: ☐ None ☐ Joint ☐ Cracks ☐ Mortar ☐ Roots ☒ **Wall**

Frame leaks. Adjustment deterioration and infiltration. Corbel and Barrel infiltration.

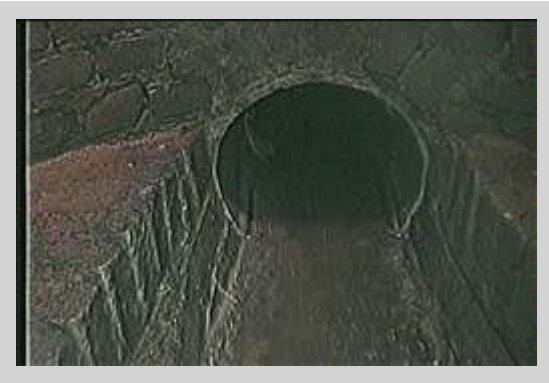
12 in. Circular Gravity Sewer Pipe Out @ 12 O'Clock

Barrel Material: **Brick** ☐ Parged
Shape: **Circular** Diameter: **42** (in.) Length: (in.)
Condition: ☐ Sound ☐ Cracked ☐ Root Intrusion ☐ Loose Brick ☒ **Deteriorated**
Infiltration: ☐ None ☐ Joint ☐ Cracks ☒ **Mortar** ☐ Roots ☒ **Wall**

Channel Material: **Brick** ☐ Parged ☐ Debris (not Condition related)
Channel Exposure: **Fully Open** Junc Dist: **0** nearest .5 ft. Azimuth:
Condition: ☐ Sound ☐ Cracked ☐ Root Intrusion ☒ **Deteriorated** ☐ Leaks ☐ Debris

Barrel deterioration and infiltration. Channel deterioration.

Infiltration: **Evidence** Pipe Seal Cond: **Cracked**

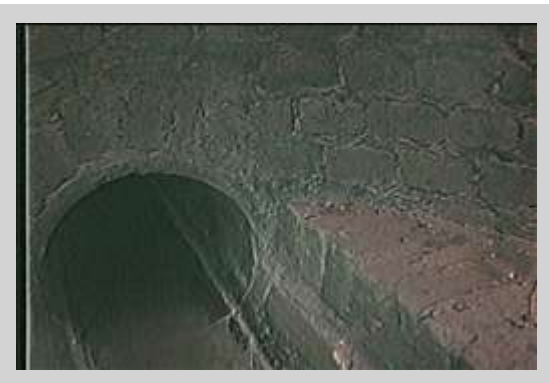
12 in. Circular Gravity Sewer Pipe In @ 5 O'Clock

Barrel deterioration and infiltration.
